Examples of use of Galvanized Reinforcement in Highways and Bridges

US Bridge survey data: 1975-2002

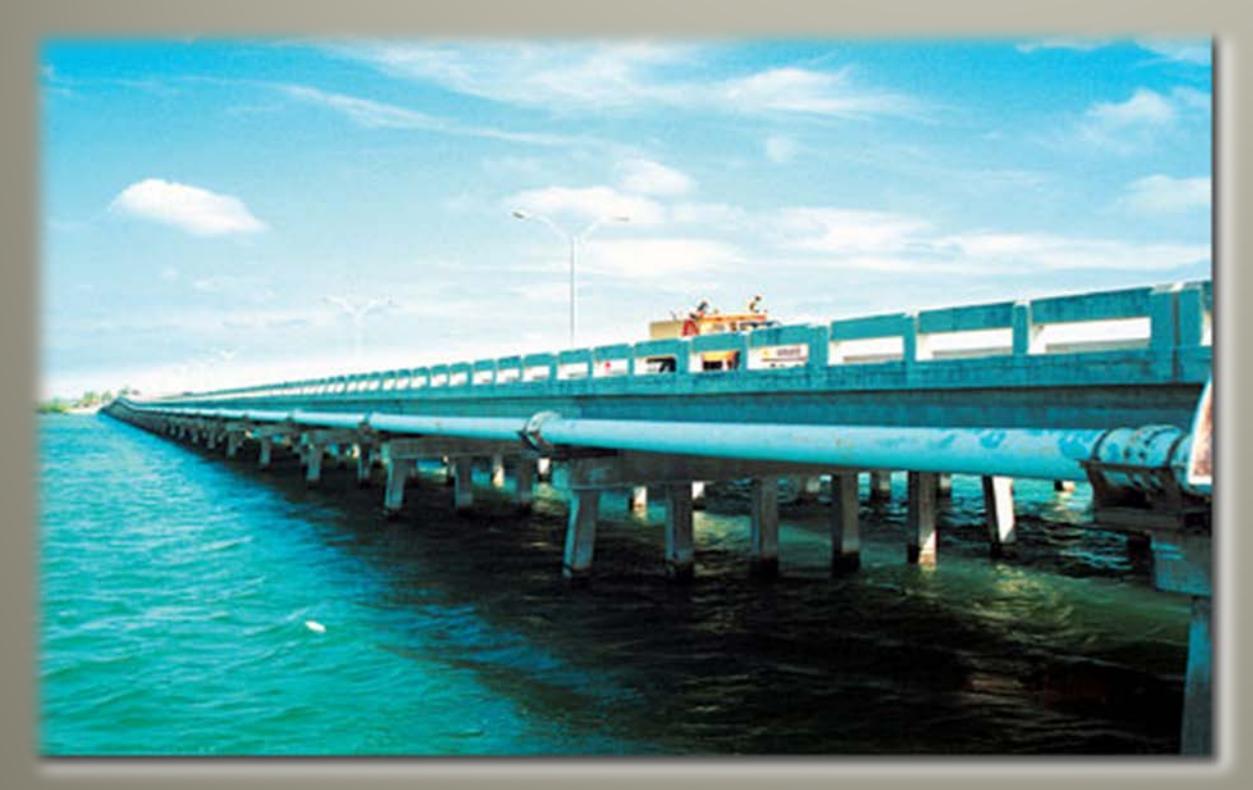
Boca Chica Bridge, Florida (1972)

Inspection Details: 1975 Zinc – 130 microns Chlorides - 1.17 kg/m³ 1991 Zinc – 102 microns Chlorides – 1.21 kg/m³ 1999 Zinc – 170 microns Chlorides – 1.93 kg/m³

Chloride levels at all inspections were well above the ACI threshold level (to 3.2x) and the residual coating thicknesses indicate an estimate of an additional 40+ years of maintenance-free corrosion protection.

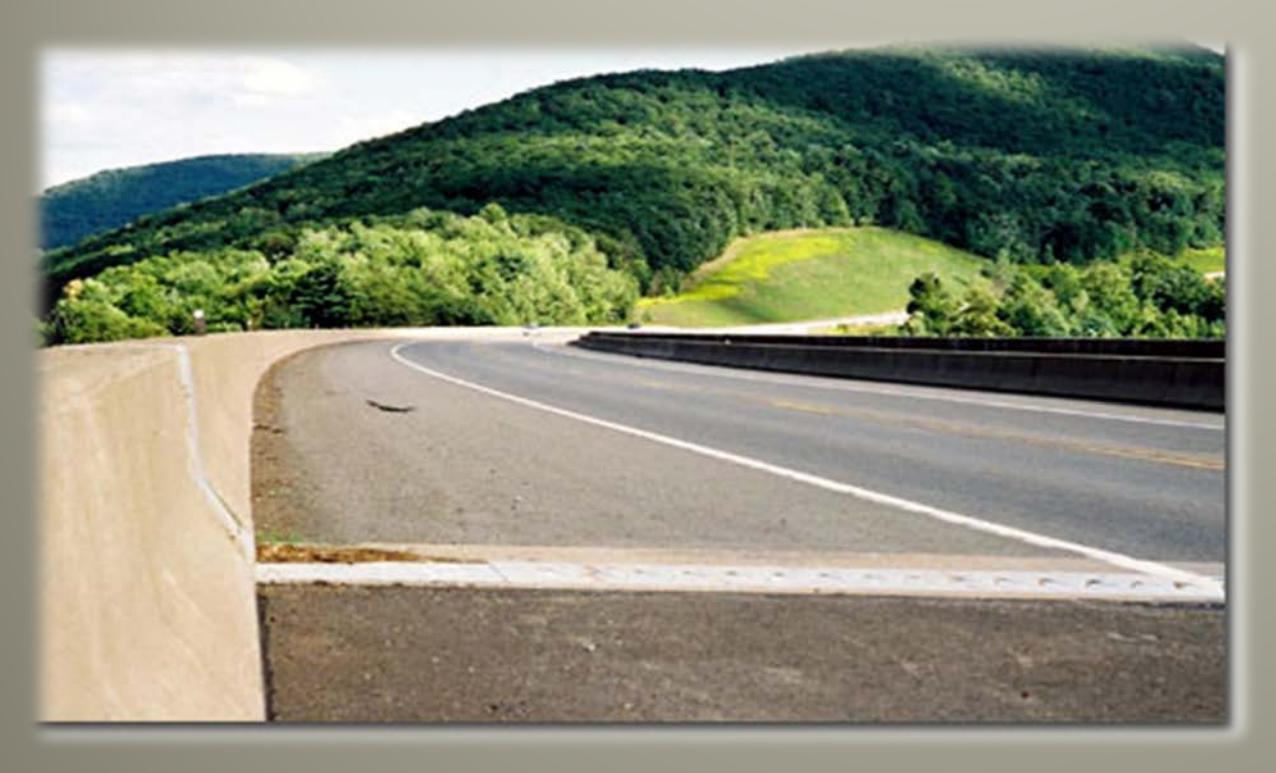
Tioga Bridge, Pennsylvania (1974)

Inspection Details: 1981 Zinc – 150 microns Chlorides – 0.35 kg/m³ 1991

- Zinc 224 microns
- Chlorides 0.64 kg/m³

2001

- Zinc 198 microns
- Chlorides 1.34 kg/m³

Chloride levels at 1991 and 2001 were well above the ACI threshold level (to 2.2x). The residual zinc coating thicknesses indicates a further 40+ years of maintenance-free corrosion protection.

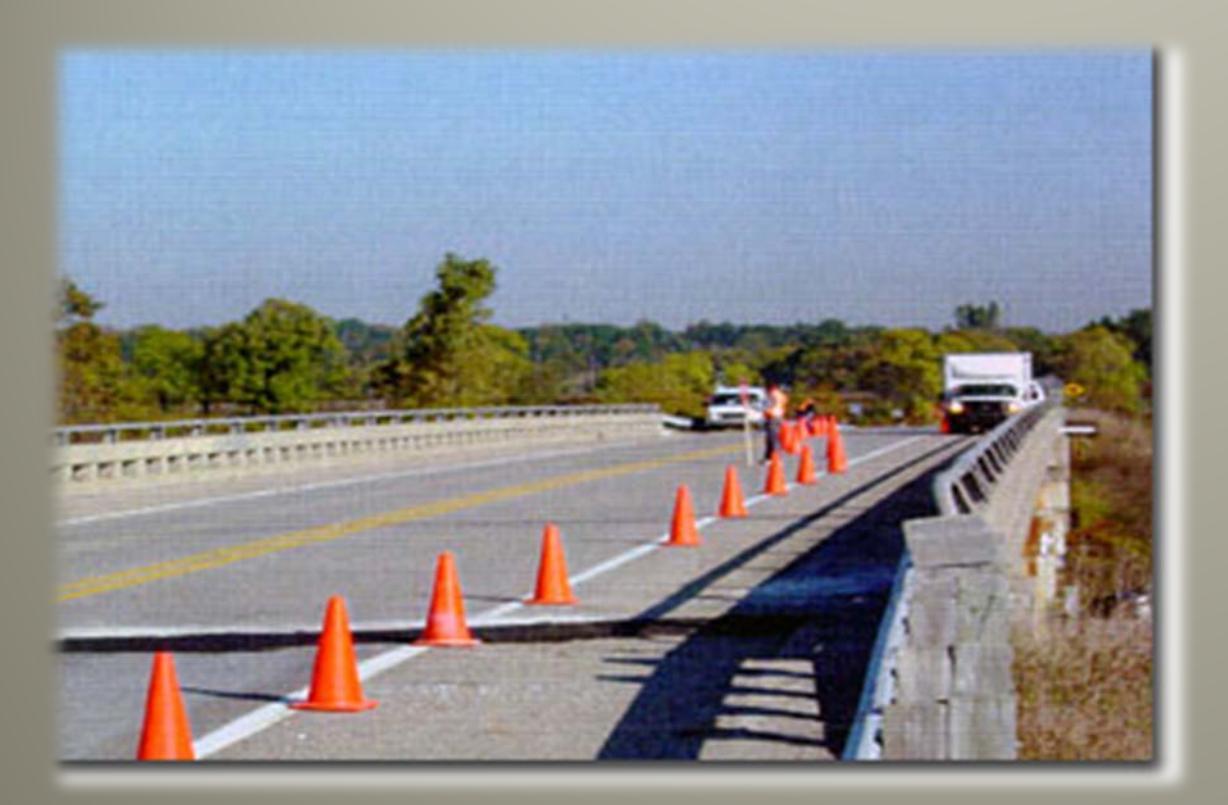
Curtis Road Bridge, Michigan (1976)

Inspection Details: 2002 Zinc – 155 microns Chlorides – 4.13 kg/m³

Chloride level at 2002 were 6.9x above threshold level for black steel. Current coating thicknesses indicate an estimated 40+ years of maintenance-free corrosion protection for the galvanized rebar deck.

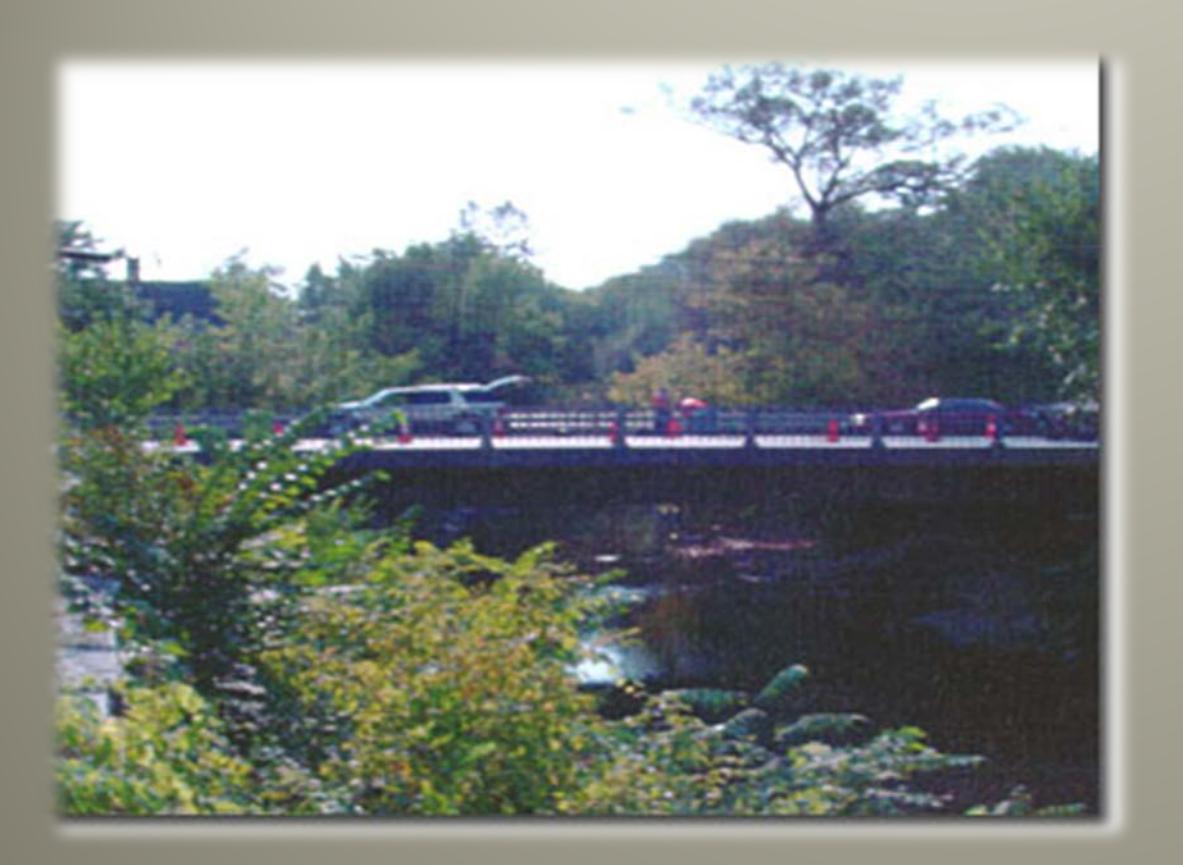
Spring Street Bridge, Vermont (1971)

Inspection Details: 2002 Zinc – 7.5 mils Chlorides – 2.50 kg/m³

Chloride levels were 4.2x above the ACI threshold for black steel. Galvanized bars were used in the upper mat of the bridge deck which was covered by 3.5 in of asphalt. The residual zinc coating thicknesses indicates an estimated 40+ years of maintenance-free corrosion protection.

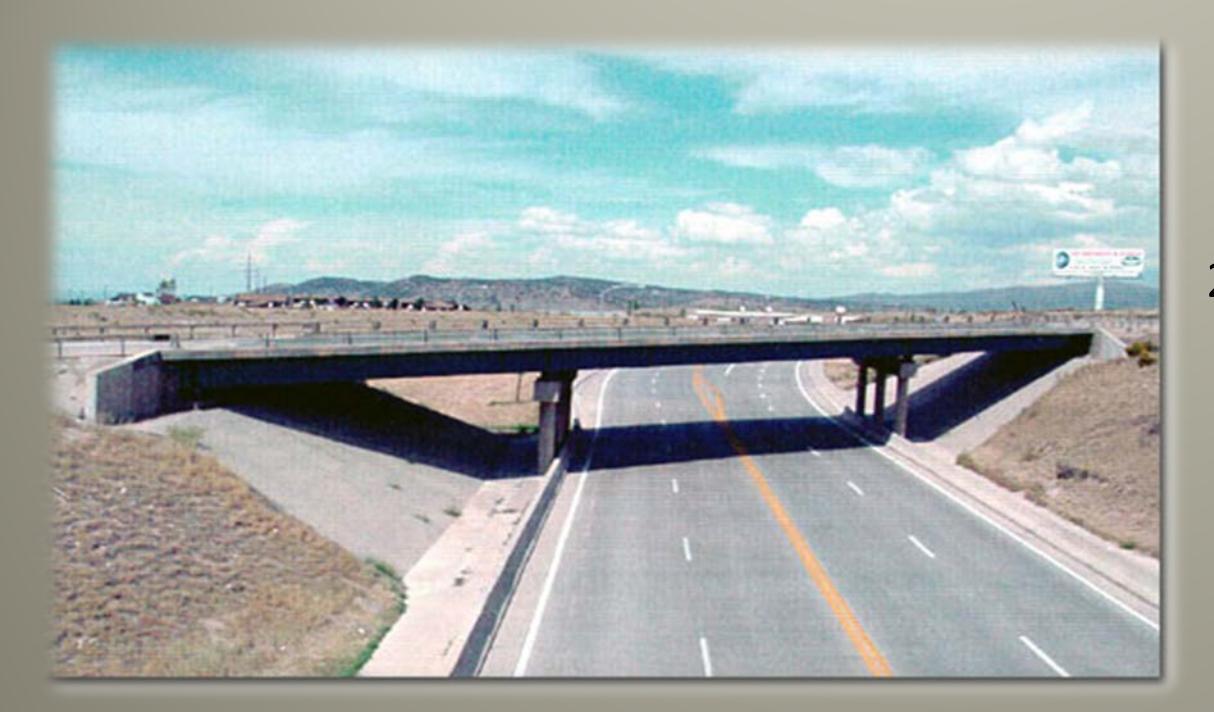
Evanston Interchange, Wyoming (1975)

Inspection Details: 2002 Zinc – 236 microns Chlorides – 1.53 kg/m³

Chloride levels were 2.6x above the ACI threshold for black steel. Galvanized bars were used in the upper mat of the bridge deck and the concrete cover was in the range 2 – 4 inches. Based on the current coating thickness, an estimated 40+ years of maintenance-free corrosion protection was predicted.

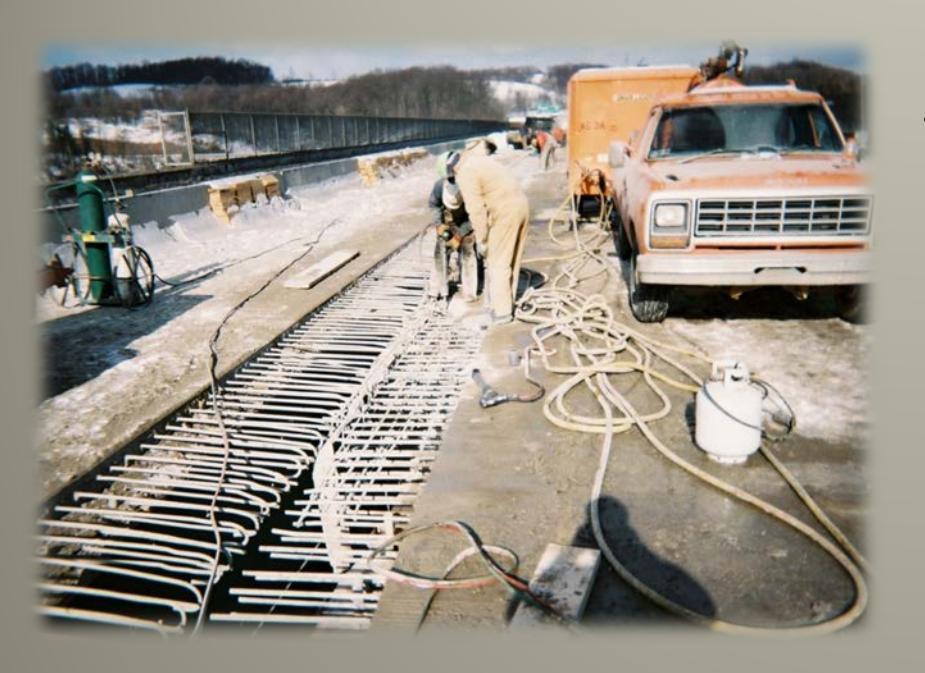
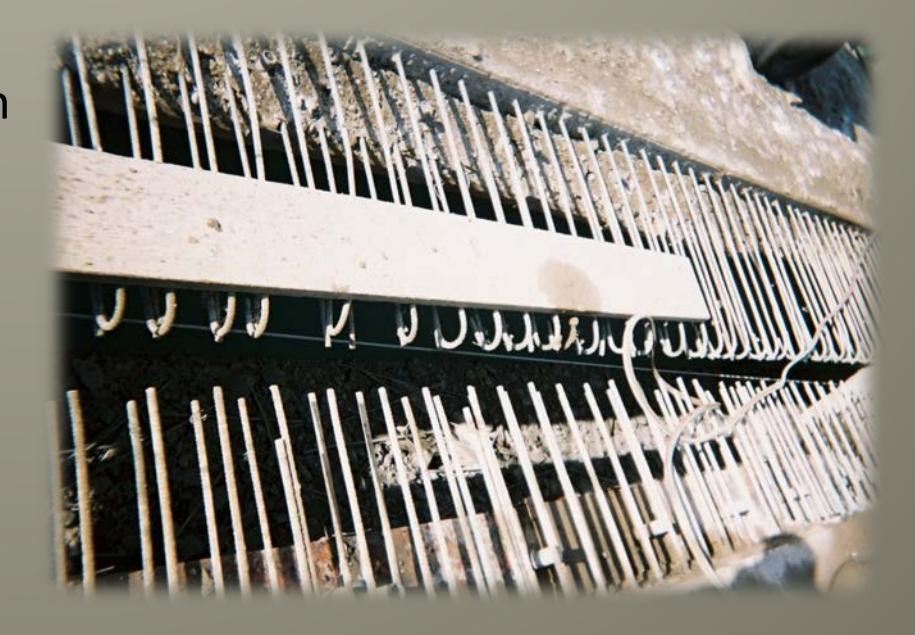
Route 66 bridge deck – a 30 year case study

The chloride content at the existing bar in the deck was 3.0 kg/m³, 5x the ACI threshold for black steel. The thickness of the zinc coating remaining was 247-270 microns , well above the specified minimum for ASTM A767 Class II coatings. There was no need for any refurbishment.

During maintenance in which a concrete Jersey crash barrier was to be installed, original galvanized deck reinforcement was uncovered. It was in excellent condition after 30 years and was cast into the new crash barrier. The tenacious bond of the bar to the surrounding concrete was noted confirming the excellent bond obtained with galvanized coatings
