Hot-Dip Galvanized Steel vs. Paint

Initial and Maintenance Cost Analysis²

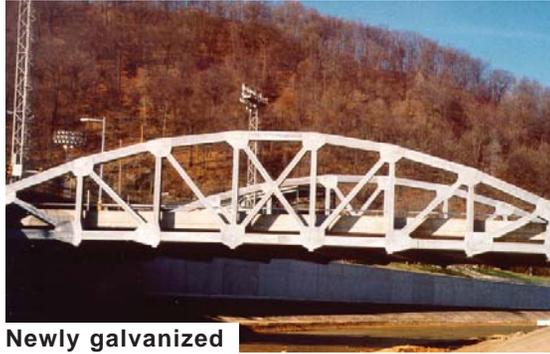
Newly galvanized

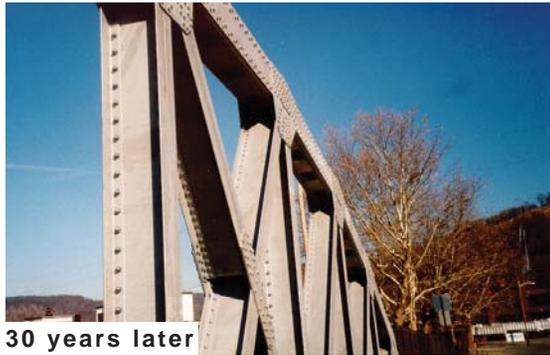
30 years later

- Hot-dip galvanized steel commonly provides maintenance-free corrosion protection for 75 years or more in atmospheric use, especially as our environment and air have become cleaner as a result of regulation.
- Sun, heat, wind, and weathering are constants that result in paint typically requiring touch-up and replacement in 12 – 15 years, costing far more than galvanizing over the intended life of the project.

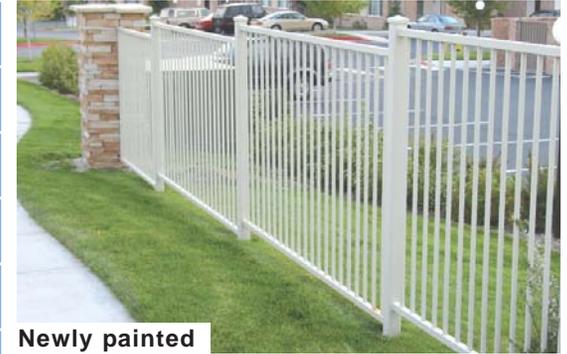
Newly painted

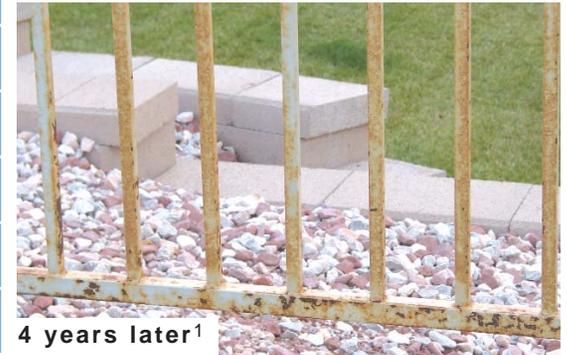
4 years later¹

¹Representative of expected results.
